INSPECTION & CONDITION SURVEY OF MARINE INFRASTRUCTURE

SUMMARY PRESENTATION

BEL MARIN KEYS COMMUNITY SERVICES DISTRICT

Simpson Gumpertz & Heger Inc.

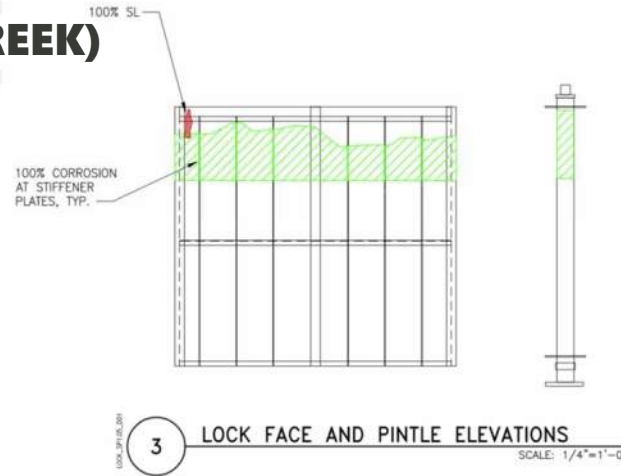
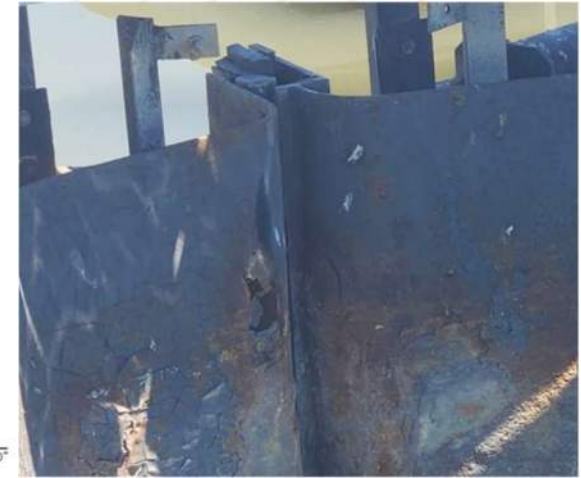
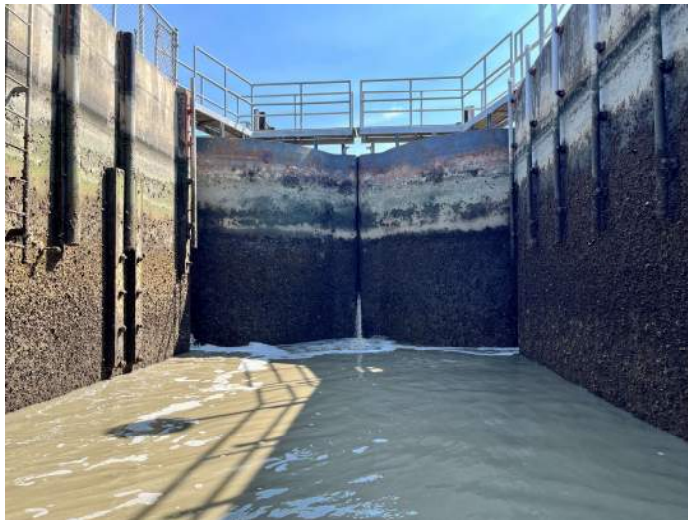
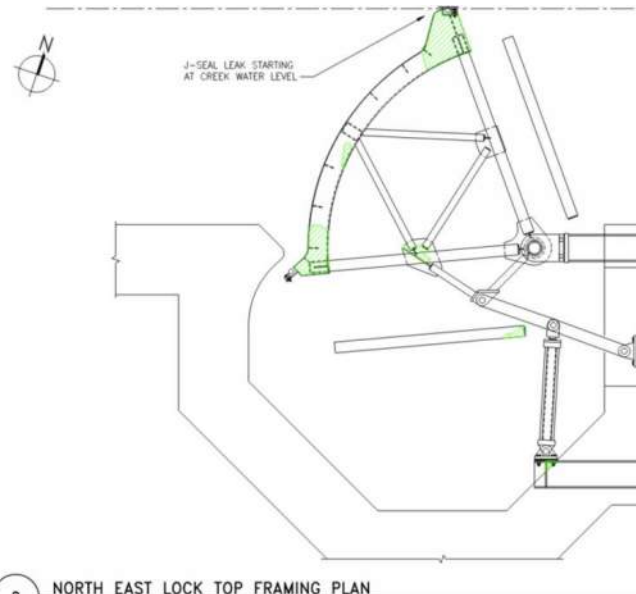
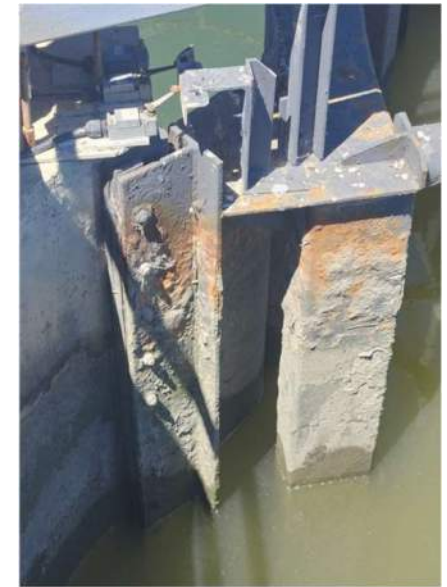
NORTH LOCK – NORTH GATES (CREEK)

Rated Fair

- Moderate deterioration observed at gate faces with widespread corrosion above waterline. One area of 100% SL at top of gate NW gate face near middle J-seal
- Middle seam and NW J-seals leaking starting at creek water level

- Replace all gate J-seals
- Replace zinc anodes
- Clean and recoat all steel members not repaired

- Repair lagoon side gate faces and deteriorated members and connections

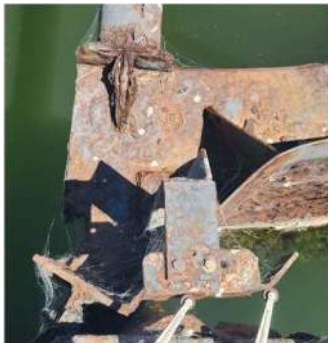
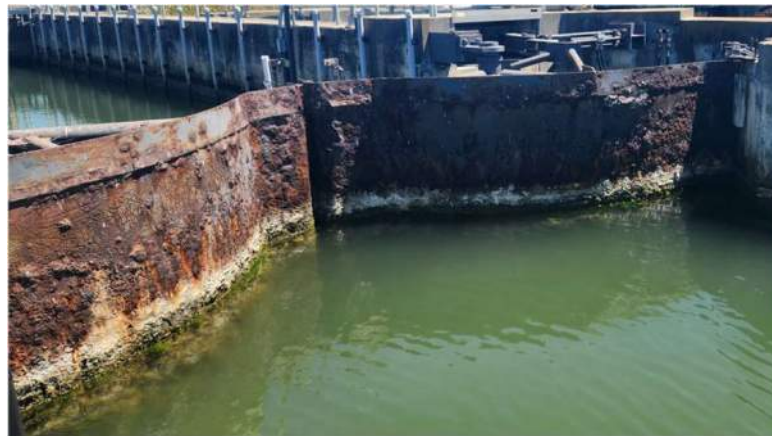
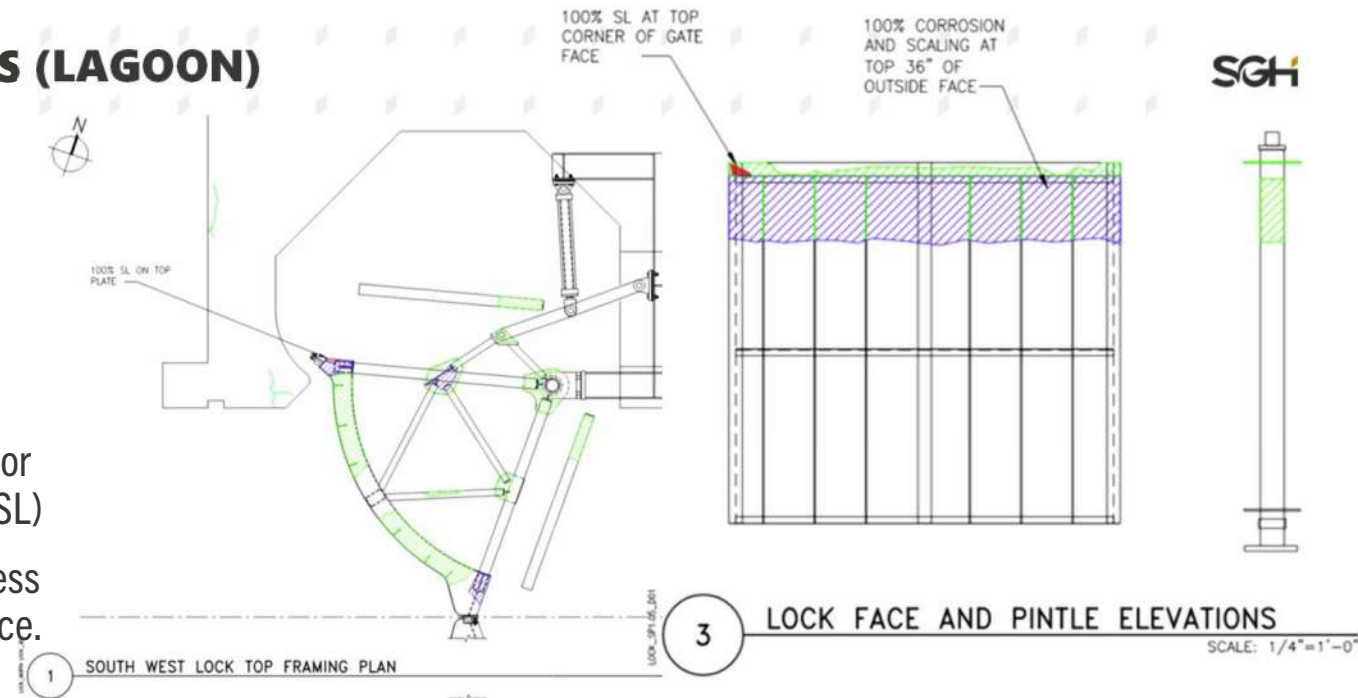
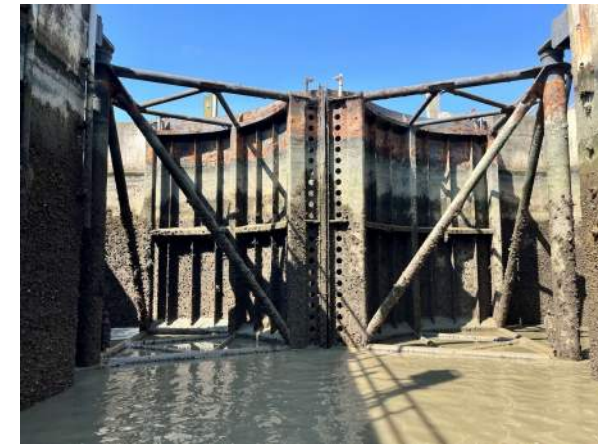
NORTH LOCK – SOUTH GATES (LAGOON)

Rated Poor

- Widespread advanced deterioration observed on steel members
- Gate faces have major corrosion and blistering above waterline
- Gusset plates and connections have major scaling and blistering with section loss (SL)
- Horizontal steel members rated Minor, less than 50% corrosion around circumference.
- Diagonal and vertical members have moderate corrosion at top ~24 in.

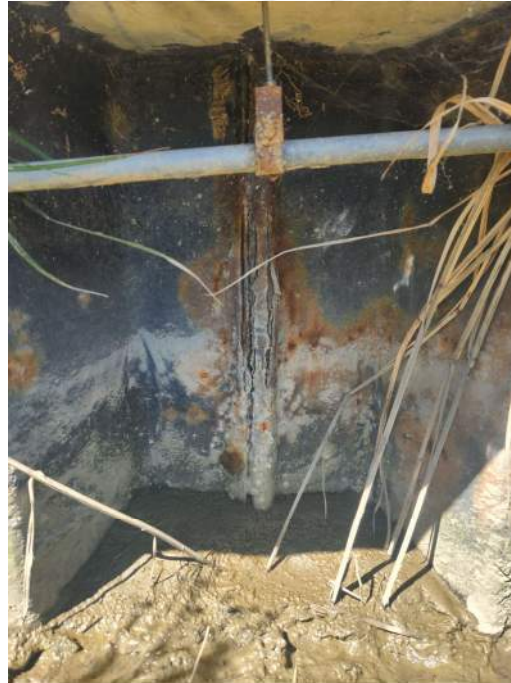
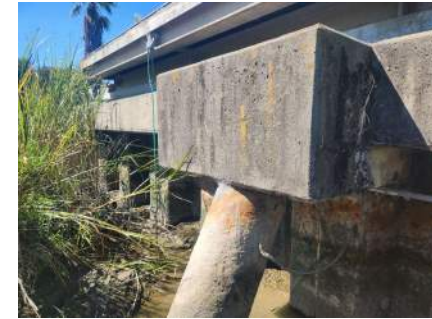
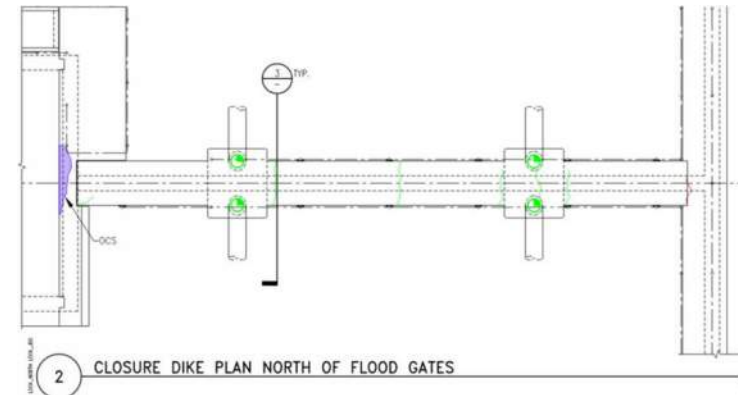
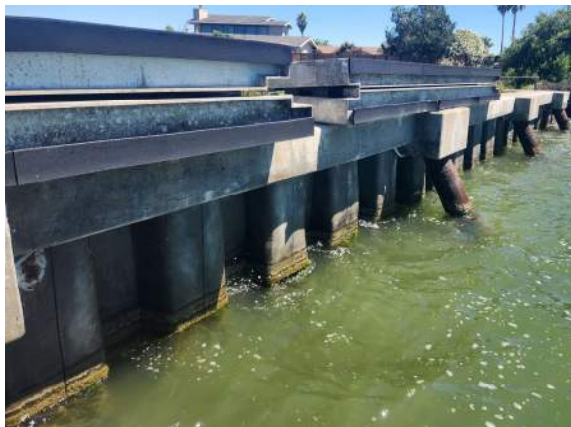
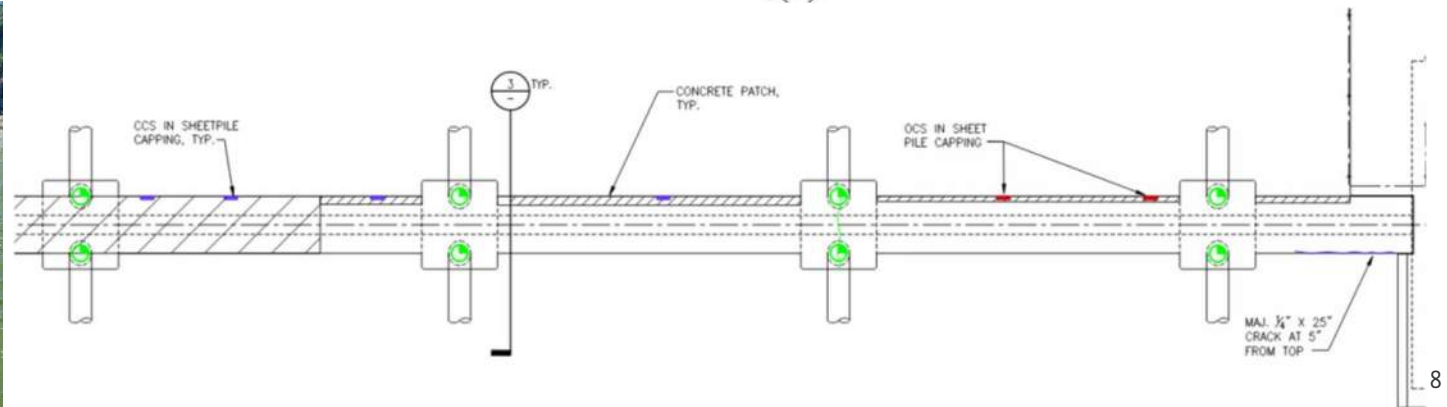
NORTH LOCK SEAWALL

Rated Fair

- All (20) batter piles – Moderate, up to 100% corrosion and scaling around circumference
- Concrete – Moderate, cracking in pile cap.
- Sheet piles – Moderate, >50% corrosion above water level with blistering and scaling especially prevalent at seams.
- Concrete caps over sheet piles on lagoon side - Moderate with few cracks and spalls, both open and closed

- Clean and recoat deteriorated creek side of sheet piles and batter piles
- Seal concrete cracks and repair localized spalls

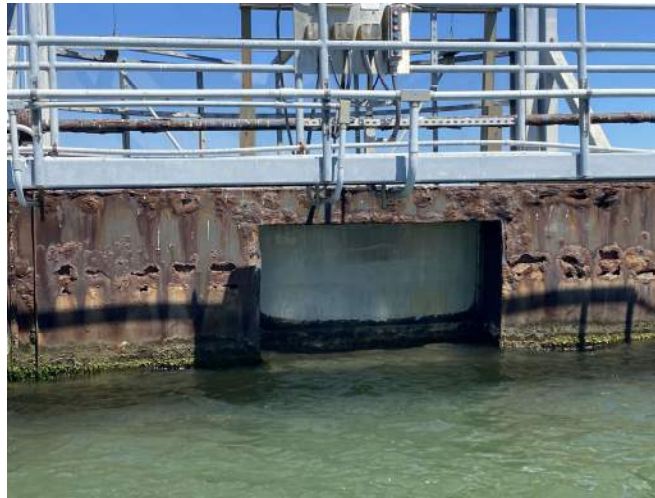
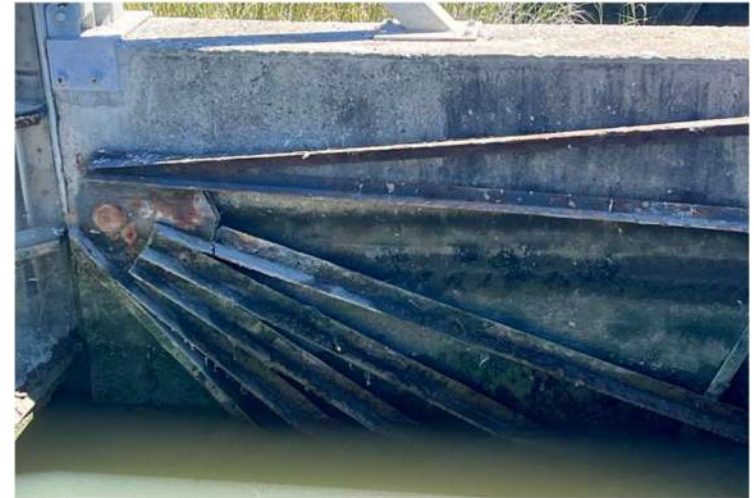
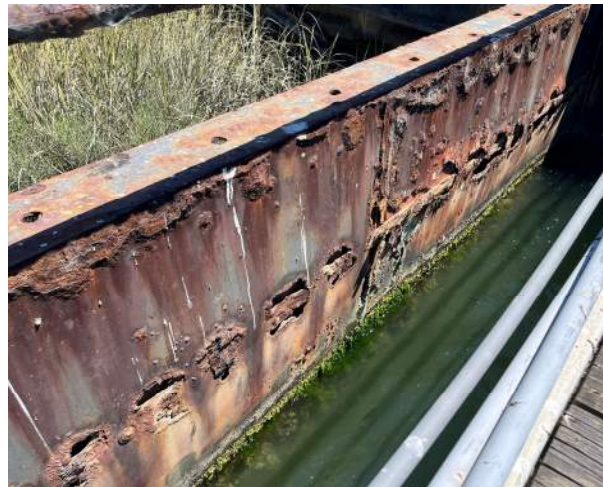
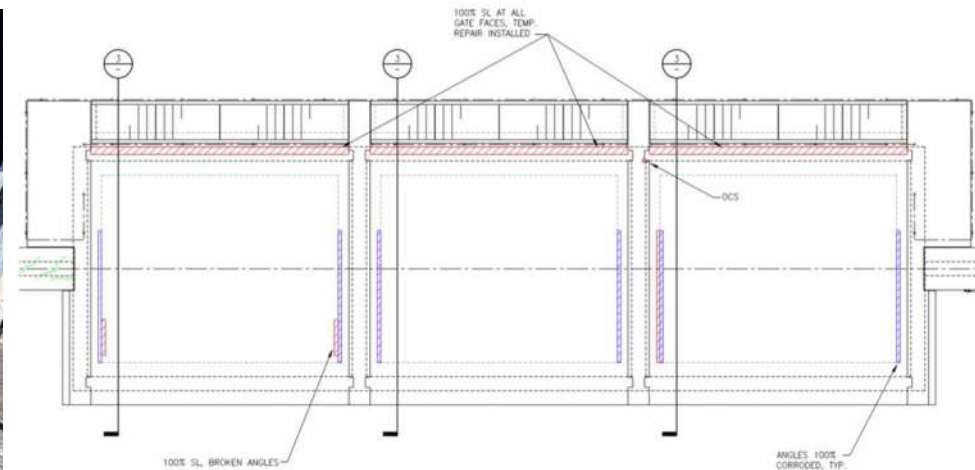
NORTH LAGOON FLOOD GATES

Rated Critical

- Very advanced deterioration and breakage has resulted in localized failures at gate faces and arms
- Multiple structural angles on arm mechanism 100% corroded and cracked through
- Gates are inoperable due to structural deterioration and out-of-order mechanical system
- Fish gates installed during previous repair, currently inoperable due to mechanical failure

- Replace gates

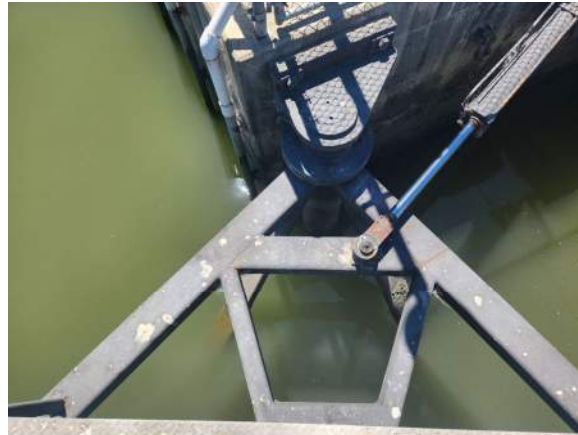
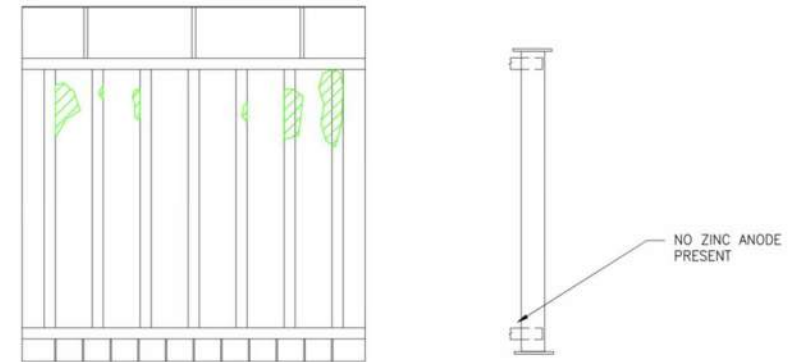
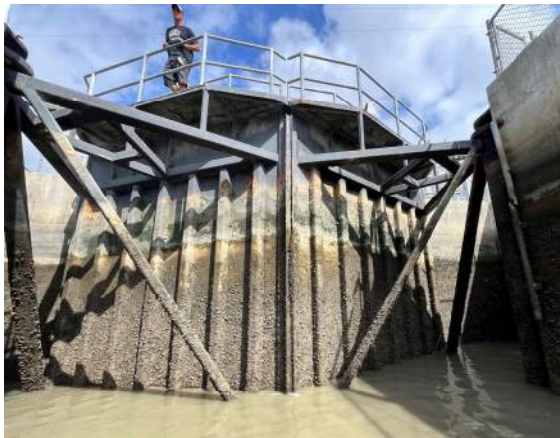
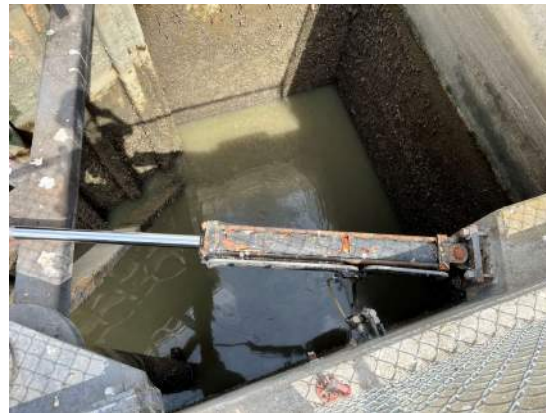
SOUTH LOCK – NORTH GATES (CREEK)

Rated Satisfactory

- Limited minor and moderate defects - limited corrosion with no overstressing
- Zinc anodes missing from NW and SE gates

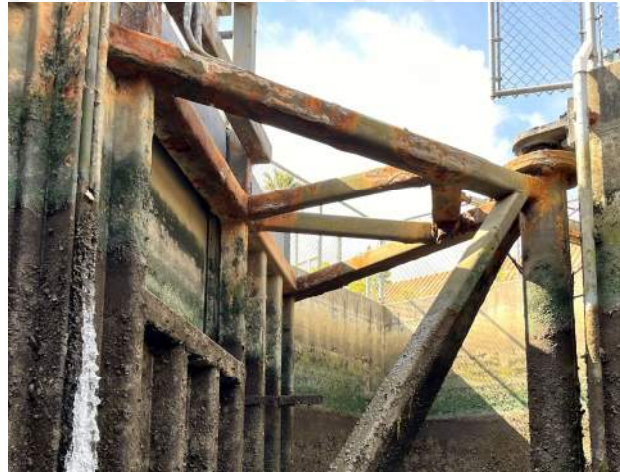
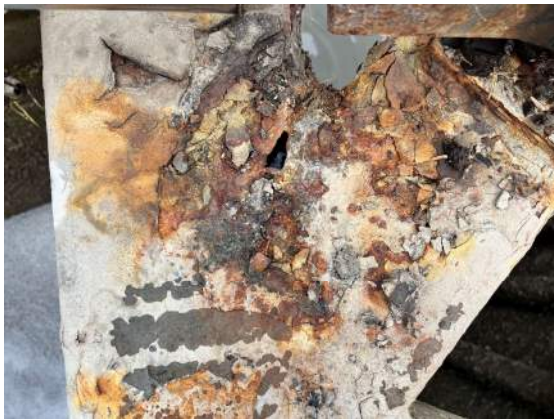
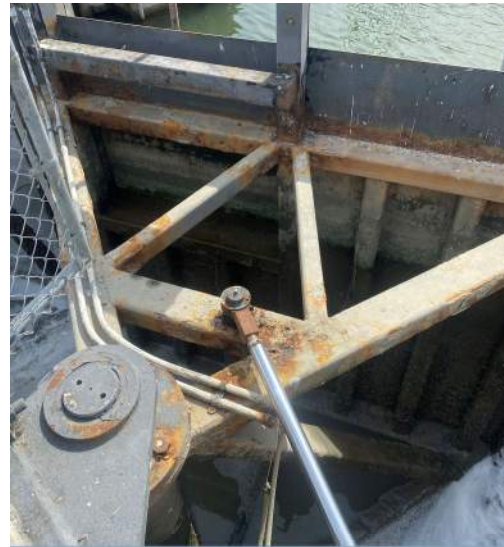
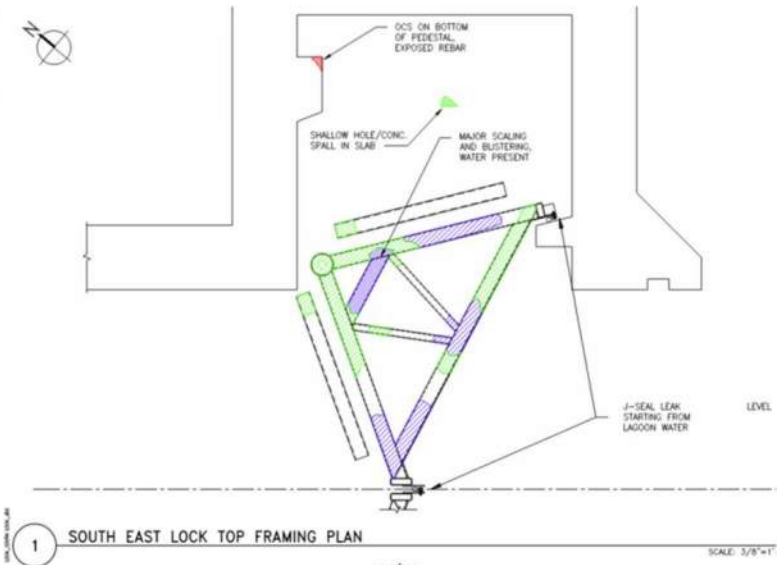
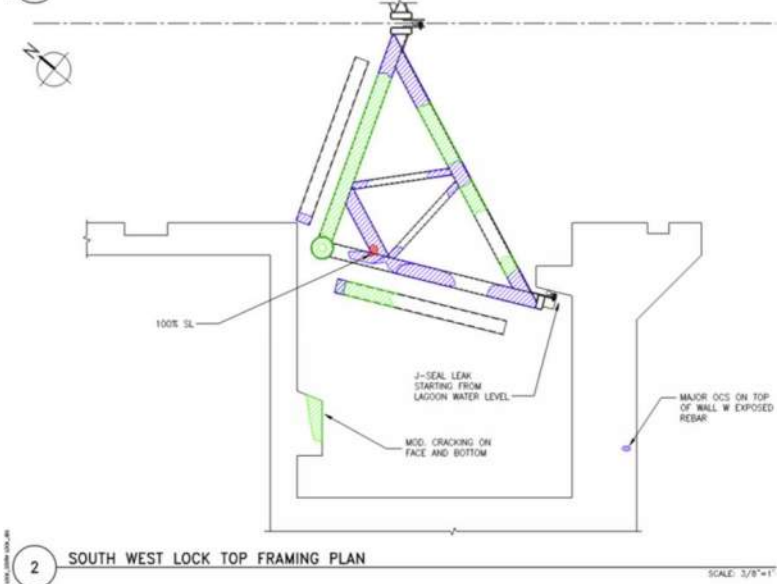
SOUTH LOCK – SOUTH GATES (LAGOON)

Rated Poor

- Corrosion on all gate members with Major and Severe areas specifically at connections and welds
- Areas of 100% SL and water present inside HSS members
- Widespread corrosion gate face and top ~24-in. of vertical and diagonal supports

- Repair/replace lagoon side gate faces and deteriorated members and connections

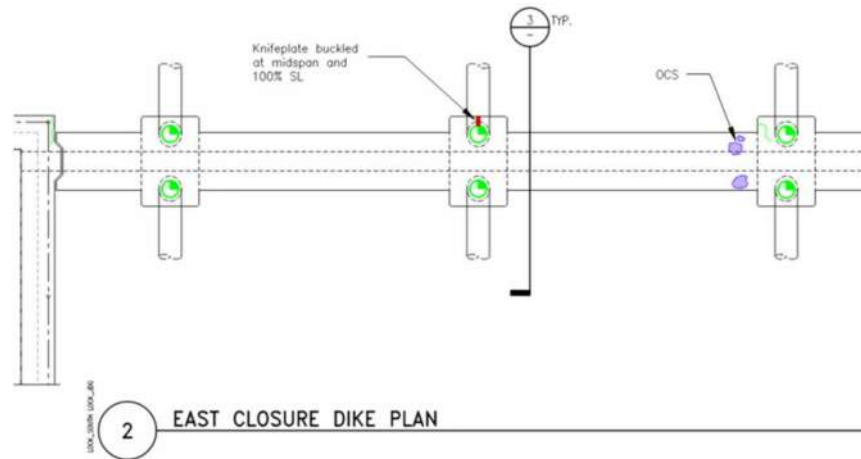
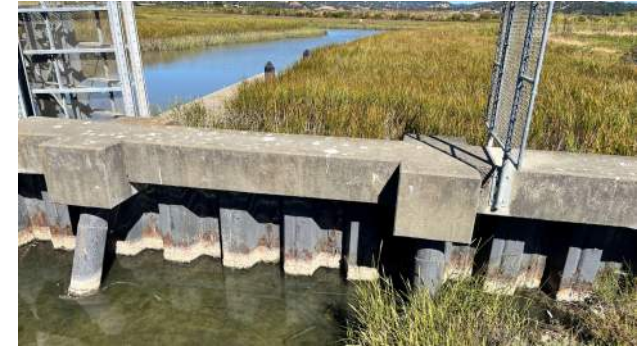
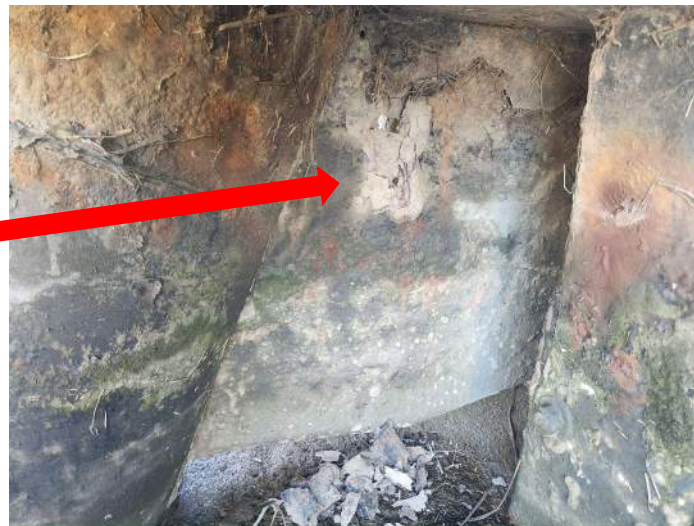
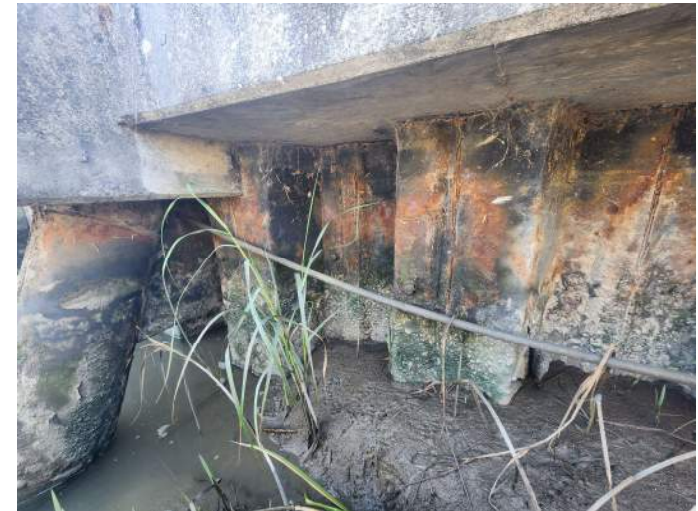
SOUTH LOCK SEAWALL

Rated Fair

- All (12) batter piles rated Moderate - Up to 100% corrosion and scaling observed. All piles are jacketed in top 36 in.
- Sheet piles rated Moderate - 100% corrosion above water level on creek side with blistering and scaling especially prevalent at seams
- (1) Knifeplate connection of sheet pile to batter pile has 100% SL and buckled at midspan

- Clean and recoat deteriorated creek side of sheet piles and batter piles

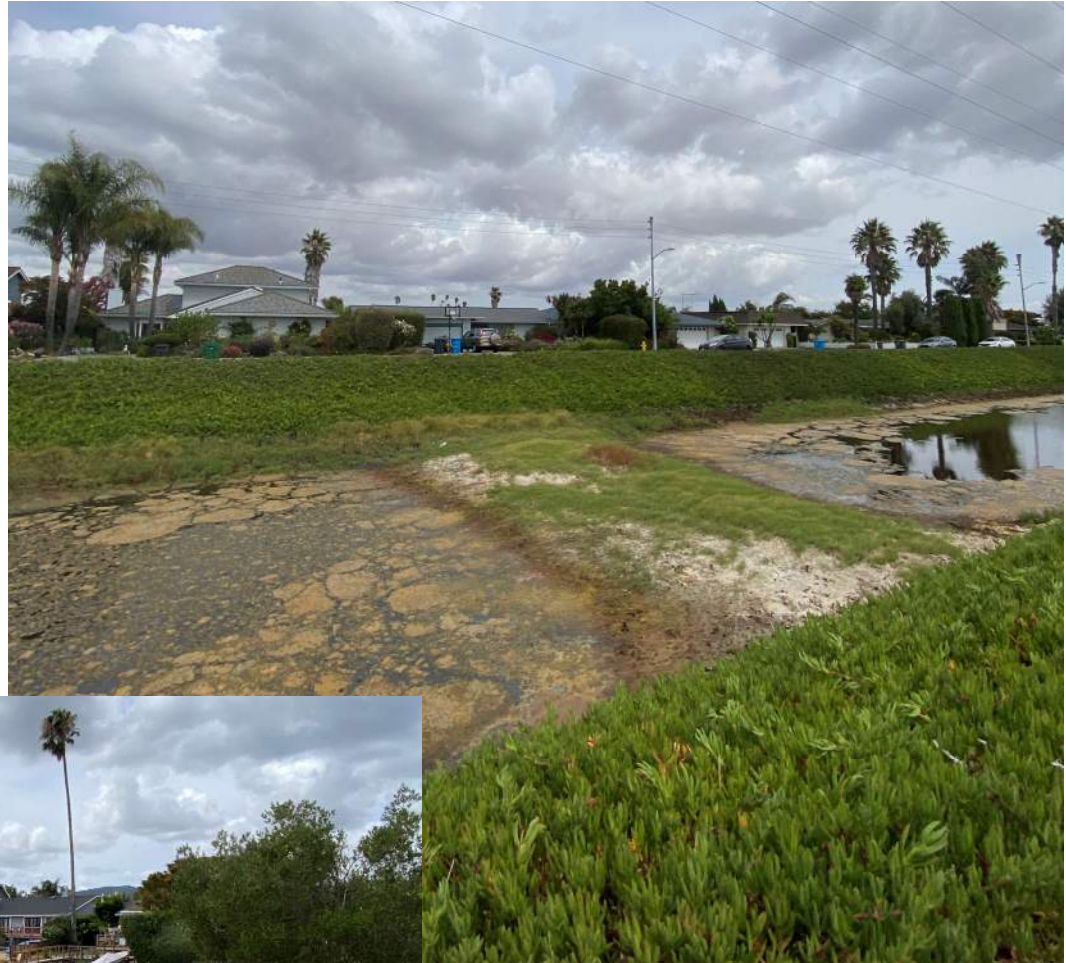
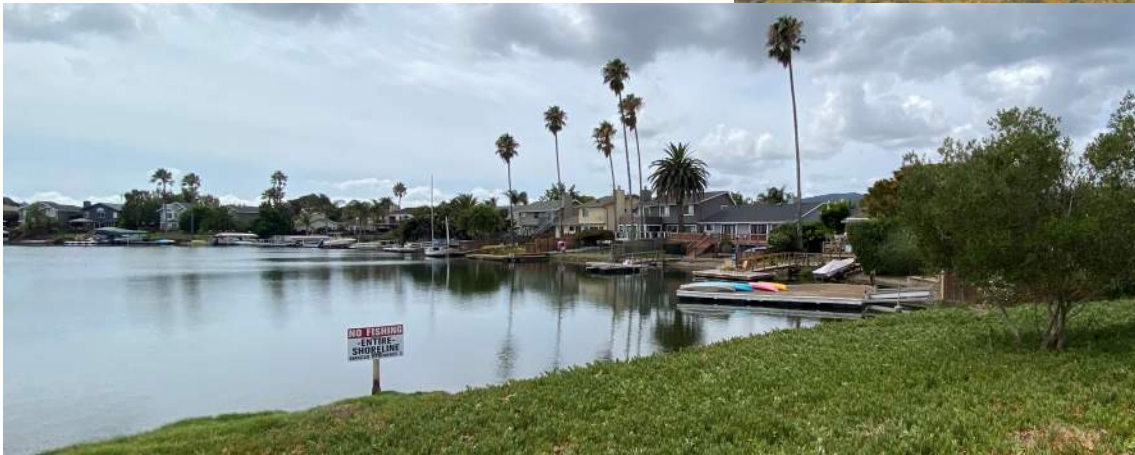
CONNECTING CULVERT

- Not visible during SGH inspection except for bump in moat between north and south lagoons.
- From “Recirculation Tubes” Memo (2003):
 - 750 ft long x 6 ft diam. concrete culvert 15-21 ft below grade.
 - Inoperative for ~40 years
 - Access filled with rip-rap and dirt and gatehouse demolished

- Rebuild the connecting culvert

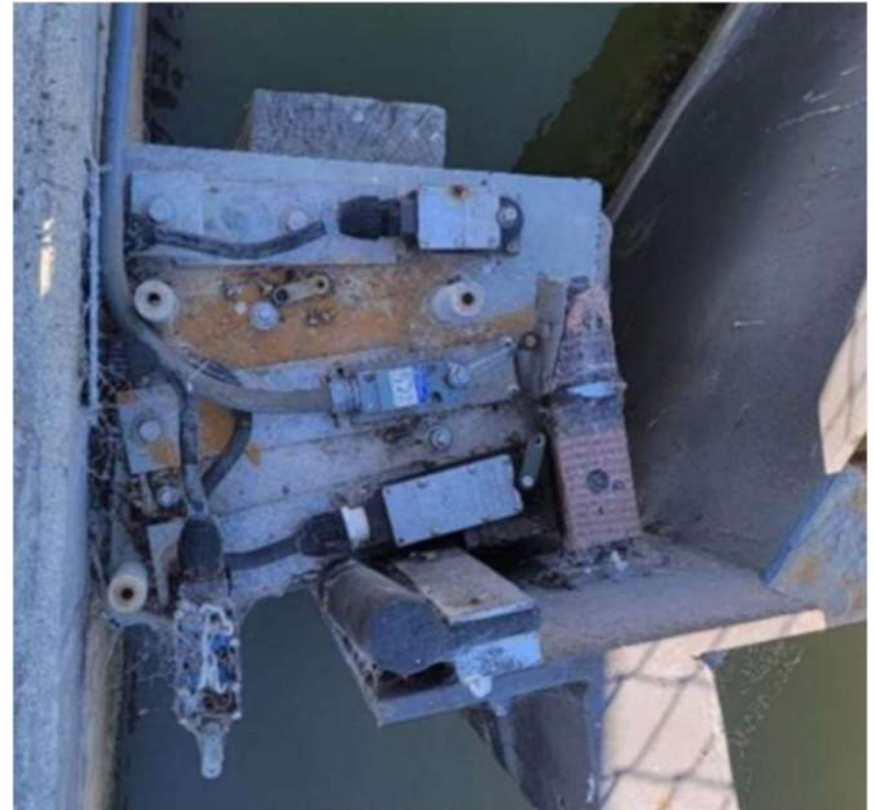
North Lock

- Fair condition
- Moderate condition of gate limit switches
- No hydraulic components in obvious need of repair or replacement, should consider rebuilding cylinders as preventative maintenance.

- Disassemble, clean, lubricate linkages, hinges, and cylinders.
- Rebuild hydraulic cylinders and rods.
- Provide functional bellows.
- Replace hydraulic hoses
- Service crane and vehicle bridge at the South Lock should be repaired and made operable if desired.

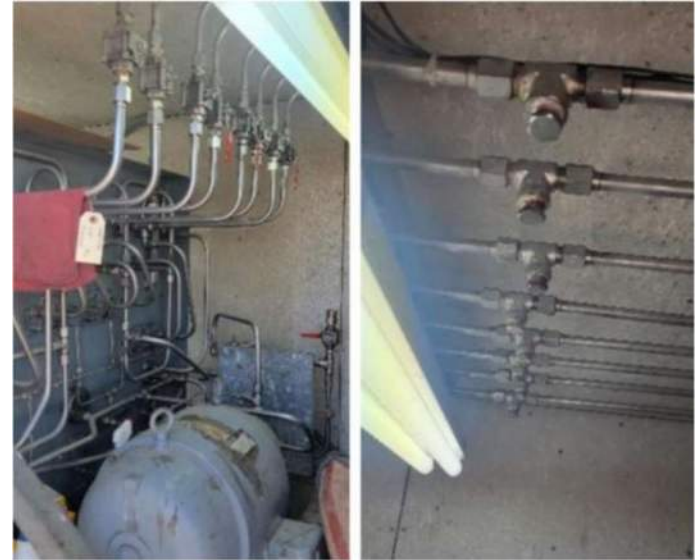
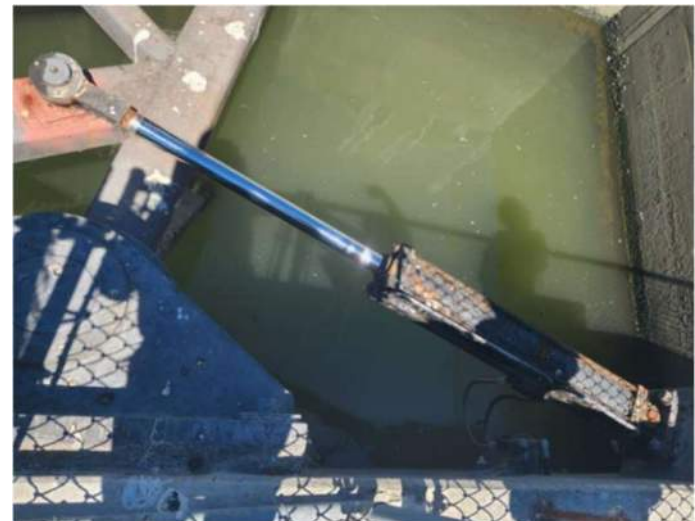
South Lock

- Fair condition
- Small persistent leak in hydraulic tubing behind control panel
- Cylinders are extended in closed gate position exposing rods to weather, protective bellows would extend the life of rods
- Moderate condition of limit switches which require frequent maintenance

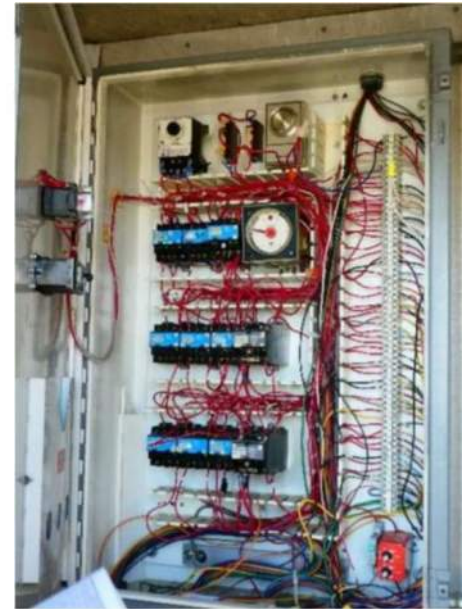
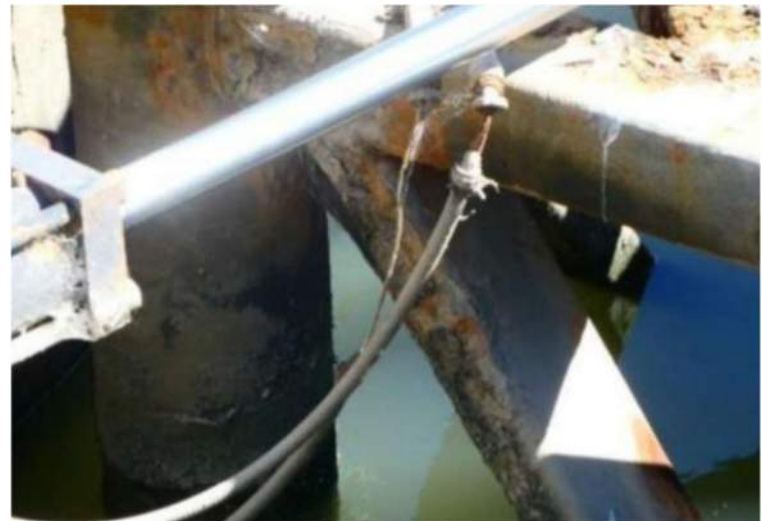
North & South Locks

- Both in **Poor condition**
- Severe physical condition with obsolete technology.
- Brittle insulation on wiring between control and gate switches
- North Lock has electrical code violations in current control system. No overload protection is provided. Emergency generator may allow back feeding into PG&E grid endangering utility workers
- South Lock control panel broken into several panels with complicated wiring

- Replace control panels with new control panels, using a programmable logic controller (PLC)
- Replace the control wiring from the control panels to the operating stations and to the gate position limit switches.
- Replace all the gate position limit switches with non-contact proximity switches
- Replace exterior flexible conduits and local junction boxes.

- Replace the main power disconnect switch at the North Lock with a “double-throw” manual transfer switch to isolate utility and generator power to the panel.
